# **IRRIGATION IN MONTANA: A PRELIMINARY INVENTORY OF INFRASTRUCTURE CONDITION**

**PBS&J**  
1120 Cedar St  
Missoula, MT 59802

January 2009

**MONTANA DNRC**  
**CONSERVATION & RESOURCE**  
**DEVELOPMENT DIVISION**  
Resource Development Bureau  
P.O. Box 201601  
Helena, MT 59620

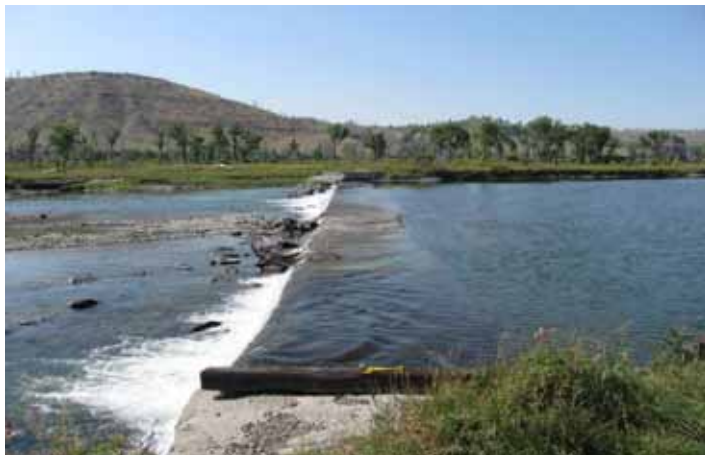
**Big Ditch Diversion Dam on the Yellowstone River**

The company's diversion dam runs from north to south across the river and is built out of concrete. The diversion appears to be in good working order and is in no need of repair. During yearly runoff events, large trees and debris sometimes get hung up on the diversion dam but only on rare occasions. The annual maintenance performed on this structure is minimal.

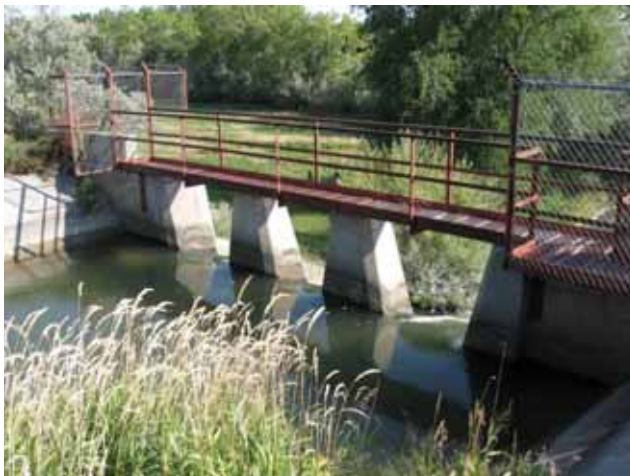
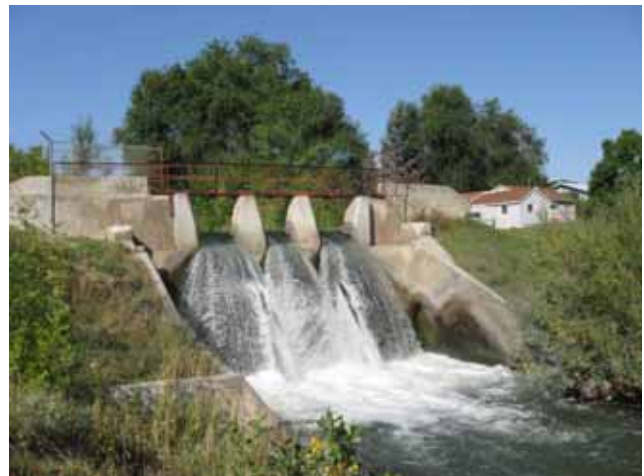
Laurel Drop Structure

The four drop points on the Big Ditch system are all similar. These structures are used to dissipate energy as water drops from a higher elevation to a lower one. All four of the drops are made of concrete and are in very good condition. Some of the drops have been recently upgraded or fixed. Overall, these structures are functioning properly and in good condition.

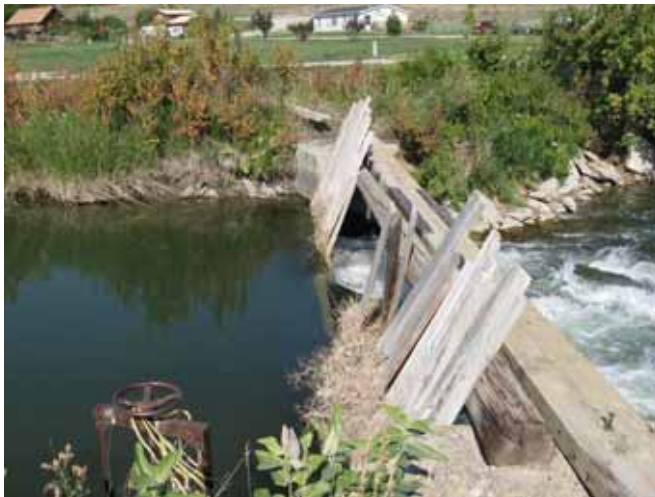
This is a point in the ditch where boards are placed to create a backwater effect. The backwater effect is used to fill a distribution ditch. This is a crude system and could be upgraded for better control.

**Benner's Check structure used to get water into distribution ditch headgate that can be seen in foreground of the photo.**

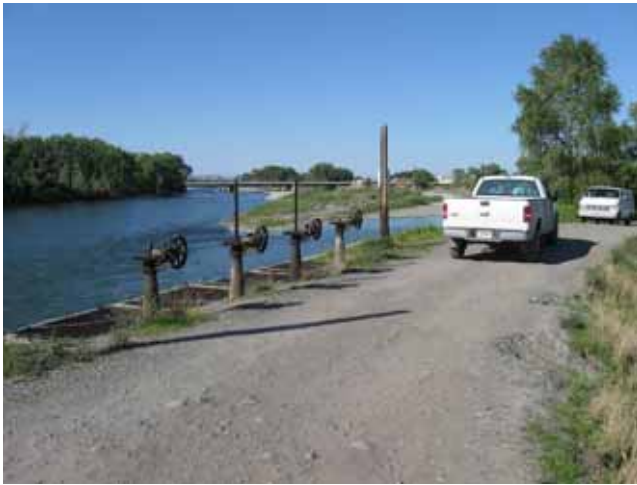
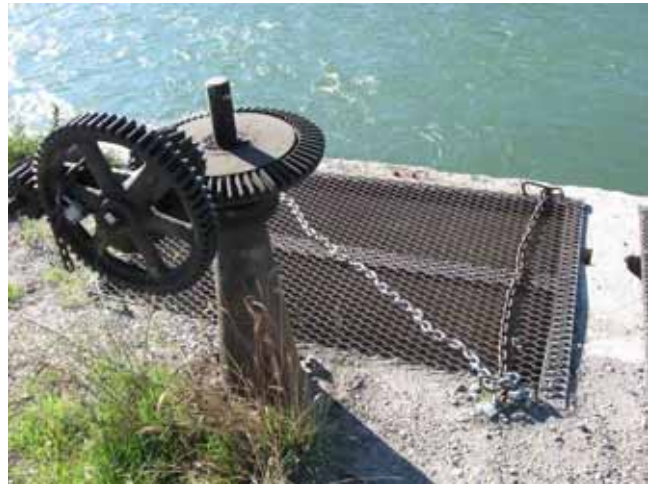
**Billings Bench Headgate**

The headgate control structure consists of four large metal slide gates. A hand crank is used to open and control the gates. This system seems to work adequately as long as the gates are only being moved less than one foot at a time. During the beginning and end of the season, a small truck is used to open and close the gates. This requires the ditch operators to remove the wheel of the truck and use the crank shaft to open and close the gates. During emergencies, the amount of time required to operate the gates is a safety issue. An upgrade of the gate control mechanism would be advisable.

There is no apparent deterioration of concrete in the headgate structure. Overall, the initial takeout point is in good condition but could use some updating on certain components.

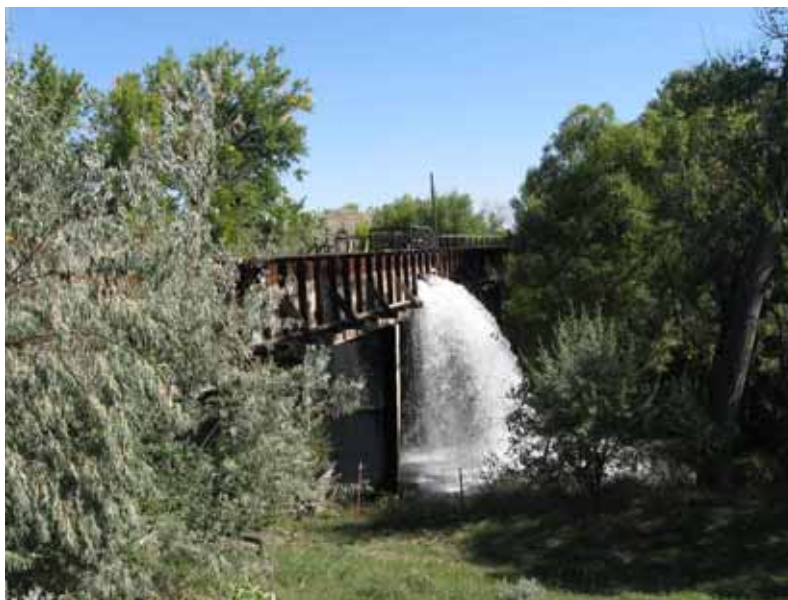
**Canyon Creek Flume**

A large wooden flume is used to convey the ditch across Canyon Creek which is on Billings West end. The structure was built in the 1940's and according to the ditch operators works rather well. There are a total of four head gates located in the middle of the flume. These head gates help control the level of the ditch. However, even with all four of the head gates open, the water level in the ditch is not adequately reduced. This has been a cause for concern in case of an emergency. The only way to shut off the ditch completely is at the initial diversion.

The overall structural integrity of the flume looks good. The large concrete piers that carry the load were intact and the frame was in good condition. The walking deck and planks need to be replaced and a structural assessment would be beneficial. A staff gauge directly downstream of the flume allows the ditch operators to judge the flow in the system at this location. However, the staff gauge has not been calibrated for a number of years.

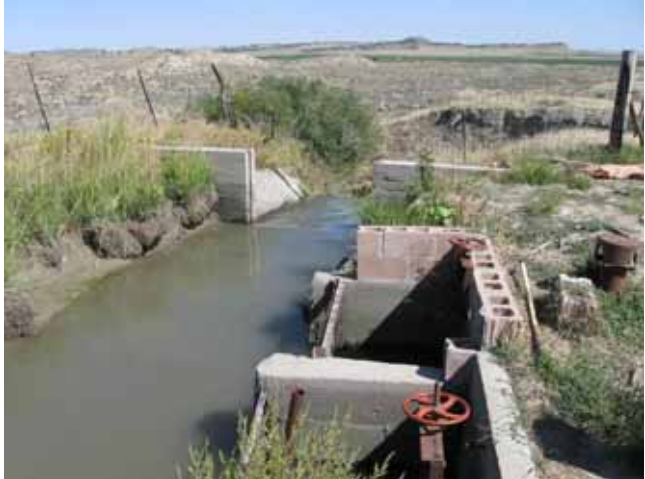
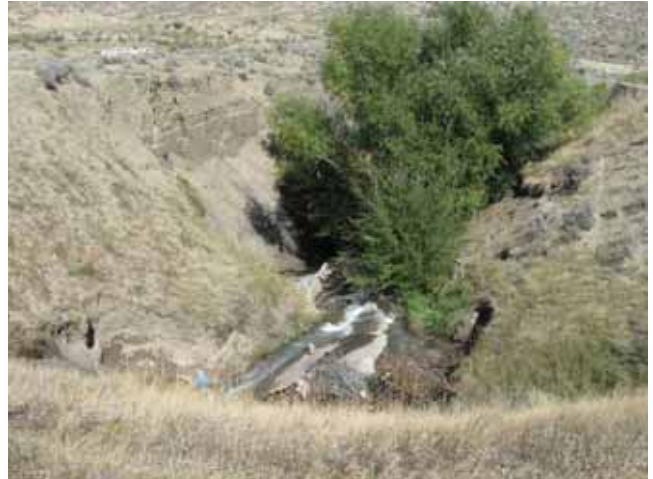
**End of the Billings Bench Canal**

The Billings Bench Canal terminates at a small coulee east of Shepherd. At this point, the ditch flows about five cubic feet per second (cfs) compared to the approximately 500 cfs that is originally diverted out of the Yellowstone. A few structural issues in this area could use some attention. For example, the large concrete spillway that helps direct the out-flow down into the coulee has collapsed and needs replacing in order to reduce erosion issues.

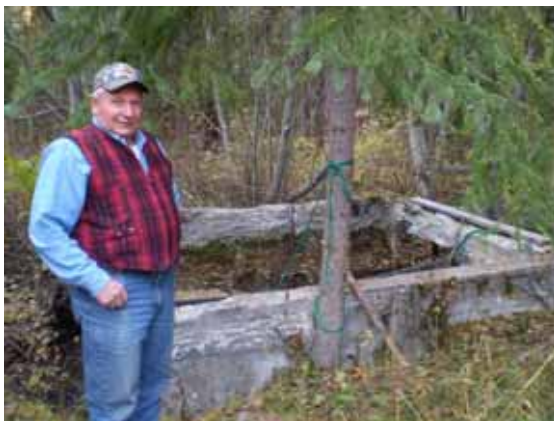
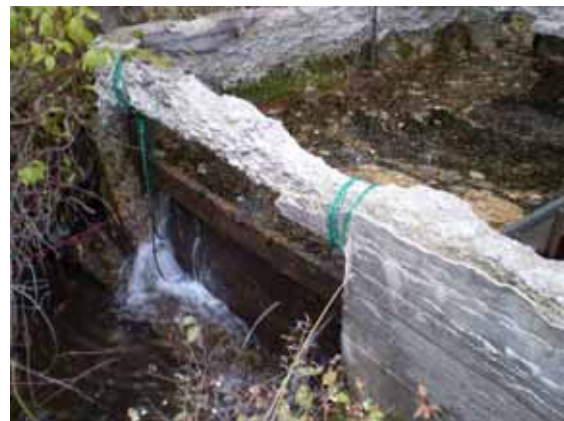
**Ed's Creek Diversion Structure**

The Ed's Creek Water Company diverts water out of Ed's Creek approximately seven miles south of Albion in western Missoula County. It is a small system that irrigates about 100 acres. The diversion structure is a concrete box constructed across the stream channel. The box functions to raise the water level high enough to fill an 8-inch pipeline. The concrete structure is badly deteriorated.

The concrete box is divided in half by a screen to prevent debris from entering the pipeline. The users have placed boards along the stream channel to keep the water flow directed toward the concrete diversion structure. This diversion system is very make-shift and is not likely to last much longer.

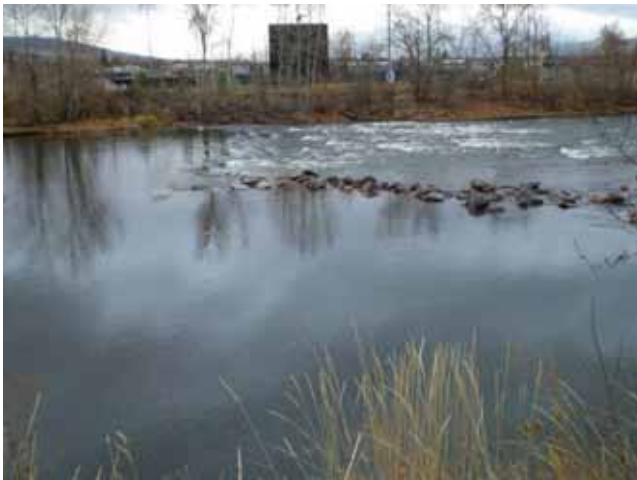
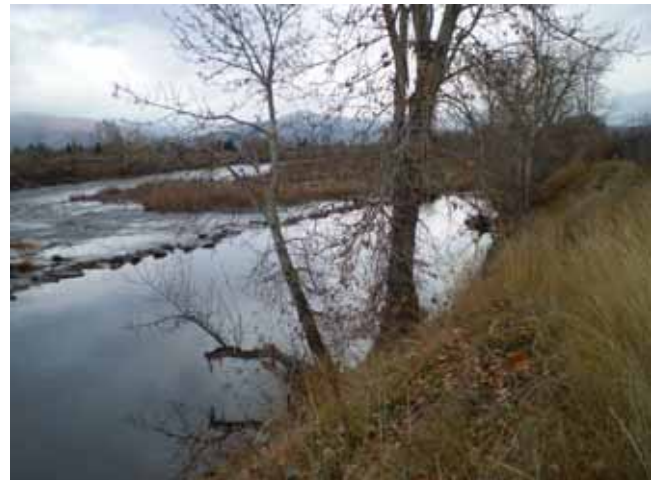
**Hellgate Valley Canal Diversion Dam**

The Hellgate Valley Canal diverts water from the Clark Fork River near downtown Missoula. The company's diversion dam is comprised of rock rip-rap that runs closely parallel to the direction of flow creating a channel on the north side of the river directing water towards the flow control structure.

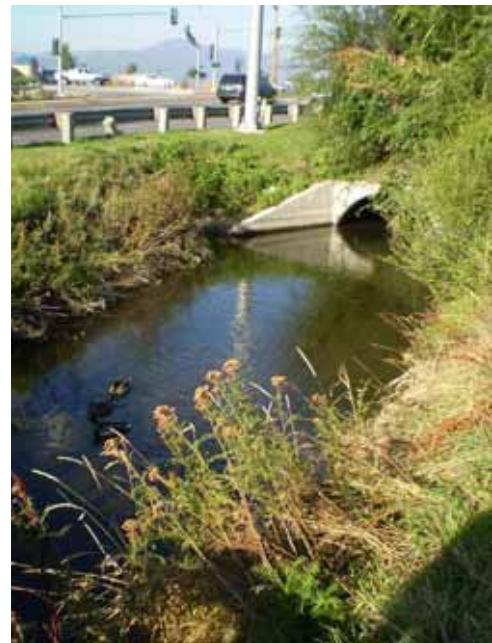
**Culvert Under the Intersection of Mullan Road and Reserve Street**

The control structure consists of two culverts, both with 2-foot diameters. There are no gates on this structure so water is allowed to flow into the system without check. Furthermore, a small beaver population chokes the channel with debris and plugs the culverts on a regular basis

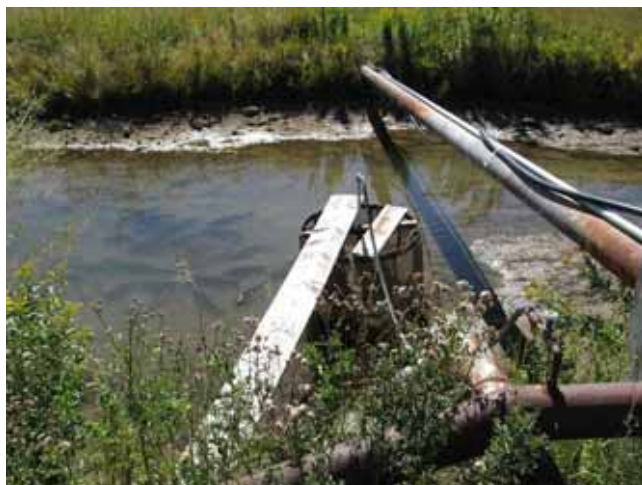
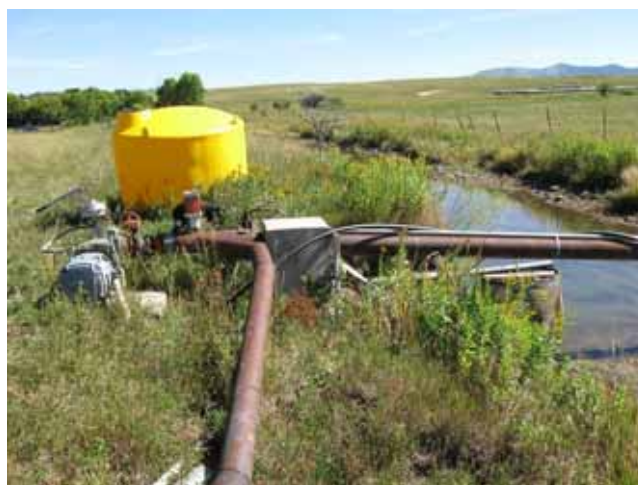
The pump site is located about ¼ mile west of Jim Phillips. The pump, motor and pipeline are in good condition but cannot run when the flow in the ditch is too low.

**Pump Station – not operating due to low flows.**

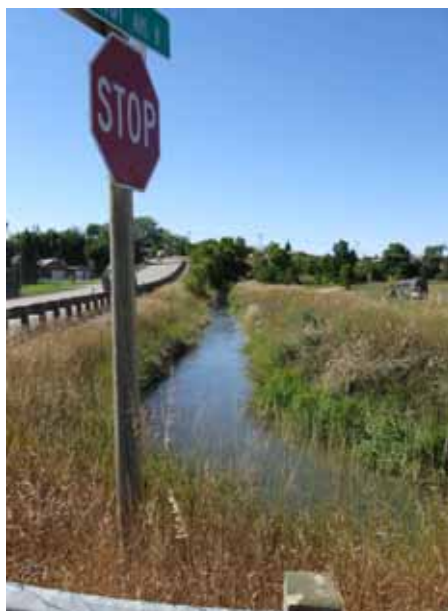
**Ditch Running Parallel to Highway**

The ditch runs parallel to a local trailer park and there has been some controversy over seepage issues. Some residents have complained to the ditch company about flooding in the crawl spaces under their homes. If seepage from the ditch is the cause of the flooding problems, lining the section of the ditch adjacent to these residences may resolve the issue.

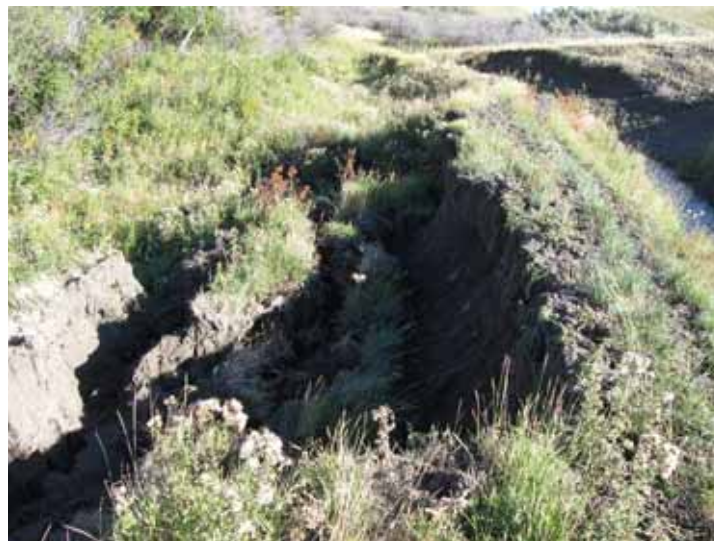
**Erosion Issues Along Ditch Bank**

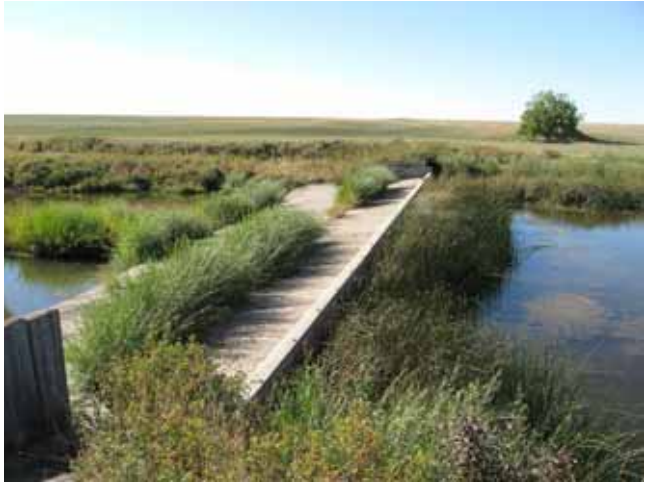
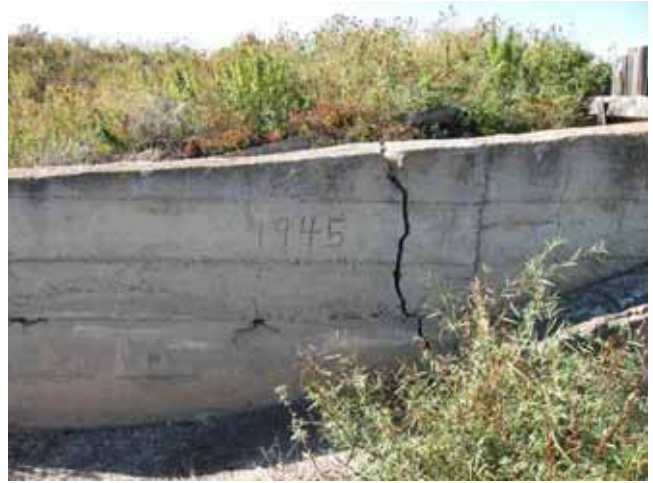
**North Chinook Diversion Dam on Lodge Creek**

The headgate control structure is located east of the diversion and consists of three metal slide gates. The structure leaks and has severe structural damage due to the freeze-thaw process in the area. Beaver activity further reduces flows in the ditch channel and causes constant maintenance problems. During high flows, an adequate amount of water gets into the system however, once flows diminish, very little, if any, water gets in the ditch.

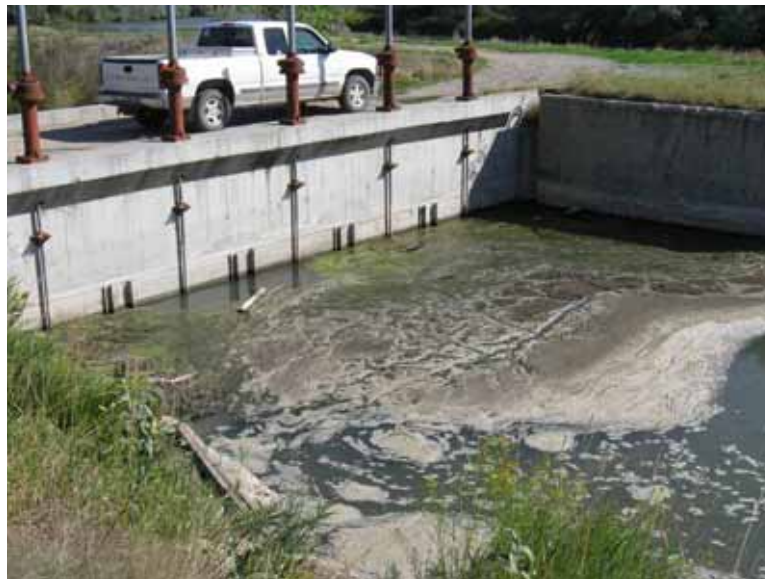
**Two Leggins Canal Headgate**

The concrete structure and the rip-rap adjacent to the headgate are in good overall condition. There are some minor cracking issues due to the freeze thaw cycle associated with a northern climate. However, large amounts of pond weed and moss choke the system and cause maintenance issues. The Two Leggins Ditch does have a moss collector about half a mile downstream from the diversion point.

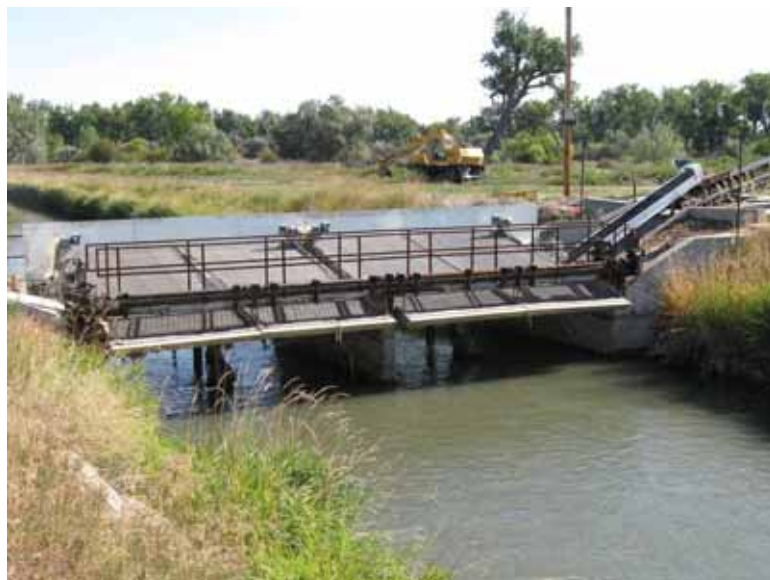
**Moss Catcher Unit**

About one hundred yards down ditch from the secondary control structure is a \$350,000 moss catching machine that is used to keep the ditch flowing properly. It was reported that the unit is relatively maintenance free and is a crucial structure to keep the ditch in working order.

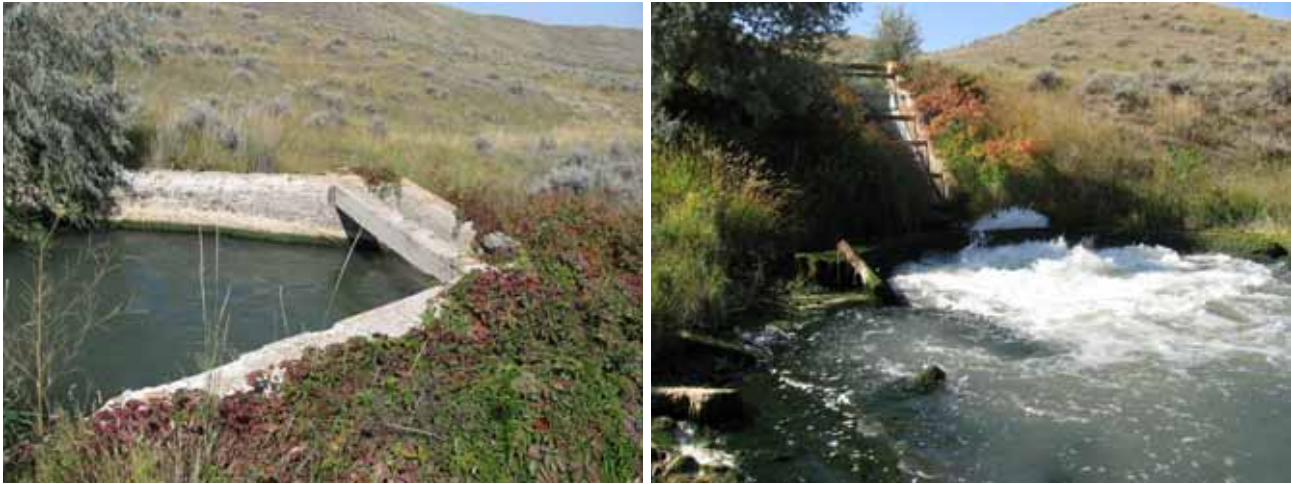
**Two Leggins Canal Drop Structure North of Interstate**

very poor condition. The concrete has deteriorated to the point where re-bar is exposed. A new drop structure that does a better job of dissipating flow energy would reduce maintenance and bring this component up to good operating standards.

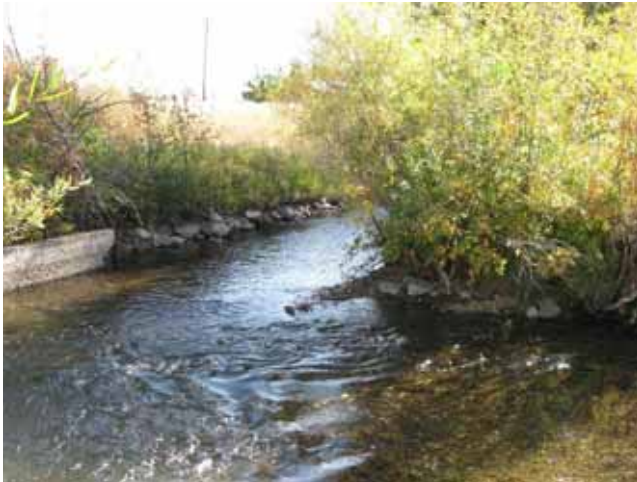
Big Bear Creek is another example of the entry point-exit point type stream crossing. The structures in this area were poorly designed to begin with and are now old and deteriorating. The operator must place boards in the check structure from the bottom up. This causes gravel, sediment and debris to build up. When it comes time to remove the boards, they must be dug out. Additionally, the ditch channel must be excavated regularly to maintain conveyance in the ditch.

**Bear Creek Entry Point (creek enters from right, in foreground)**

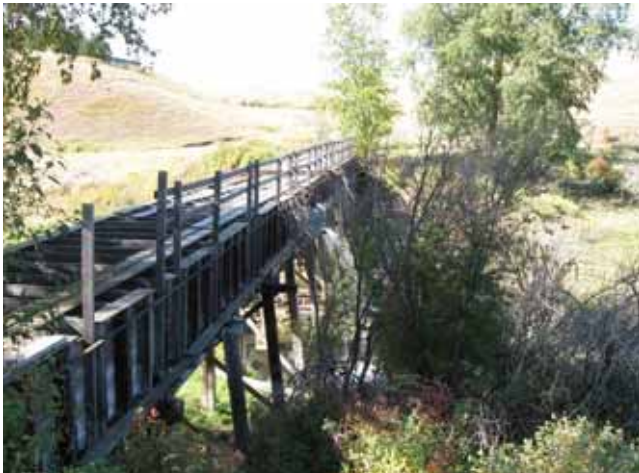
A large flume is used to convey the canal over Dry Creek. The flume and support structures are made of wood. There is a leak at the entrance of the flume which is slated for repair. The flume is about 150-200 ft long and is lined at the entrance and exit with rubber matting. The rubber matting looked to be in good condition. In the center of the flume, a small head gate allows ditch operators to release water into Dry Creek to regulate flow in the ditch or in the event of an emergency. Although the structure is old, it still operates adequately.

**Wooden Flume – Spillway Visible in Center**
